5.0 Foreshore Erosion

5.3 Condition Assessment

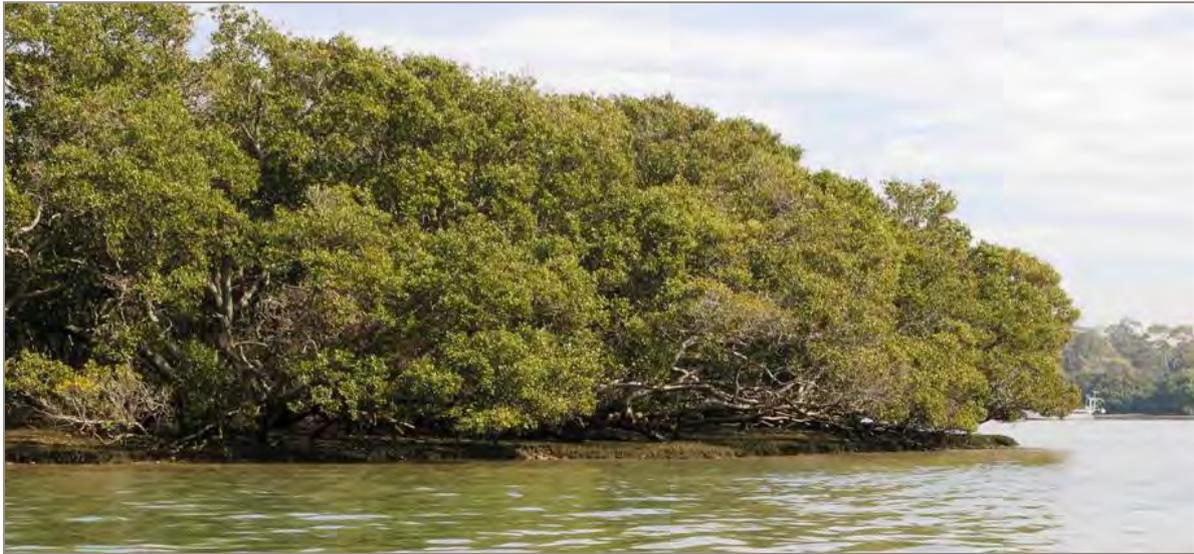
Figure 5-3. Muddy shoreline vegetated with mangroves

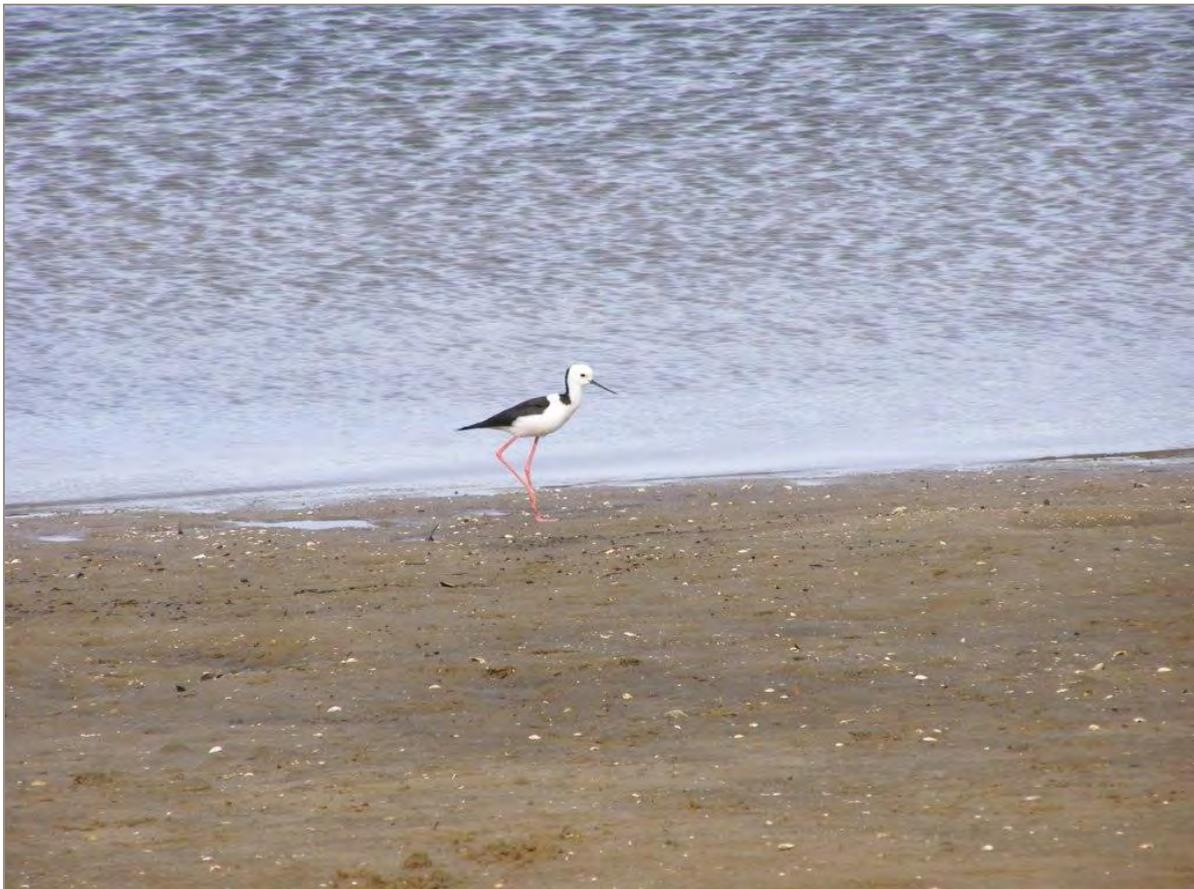
Figure 5-4. Non-vegetated muddy shoreline

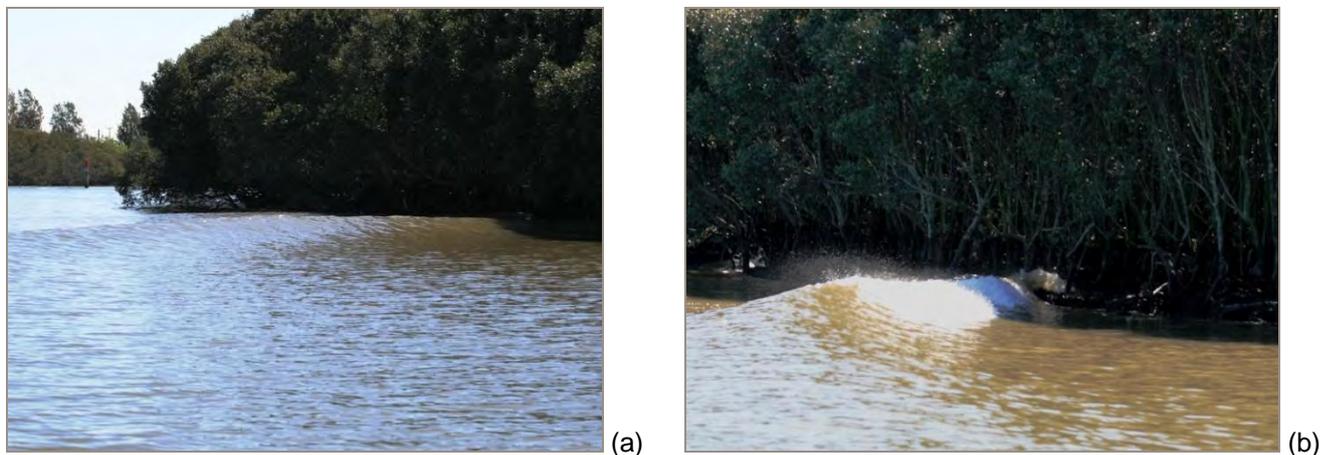
Following commencement of the service, it became apparent that the Rivercat did not meet the design wave climate specifications. The resulting long period waves (Figure 5-6) most likely have led to extensive erosion of the natural foreshore and mangrove stands on the river (Macfarlane and Cox 2007).

Figure 5-6. Ferry wash at Rydalmere upstream of Silverwater Bridge

Severe shoreline erosion from Rivercat wash resulted in restrictions to vessel operations in an attempt to alleviate further shoreline impacts (Macfarlane and Cox 2007). Nielsen and Walker (2001) showed that shoreline sediments in the Parramatta River upstream of Silverwater Bridge are susceptible to re-suspension due to wave induced currents.

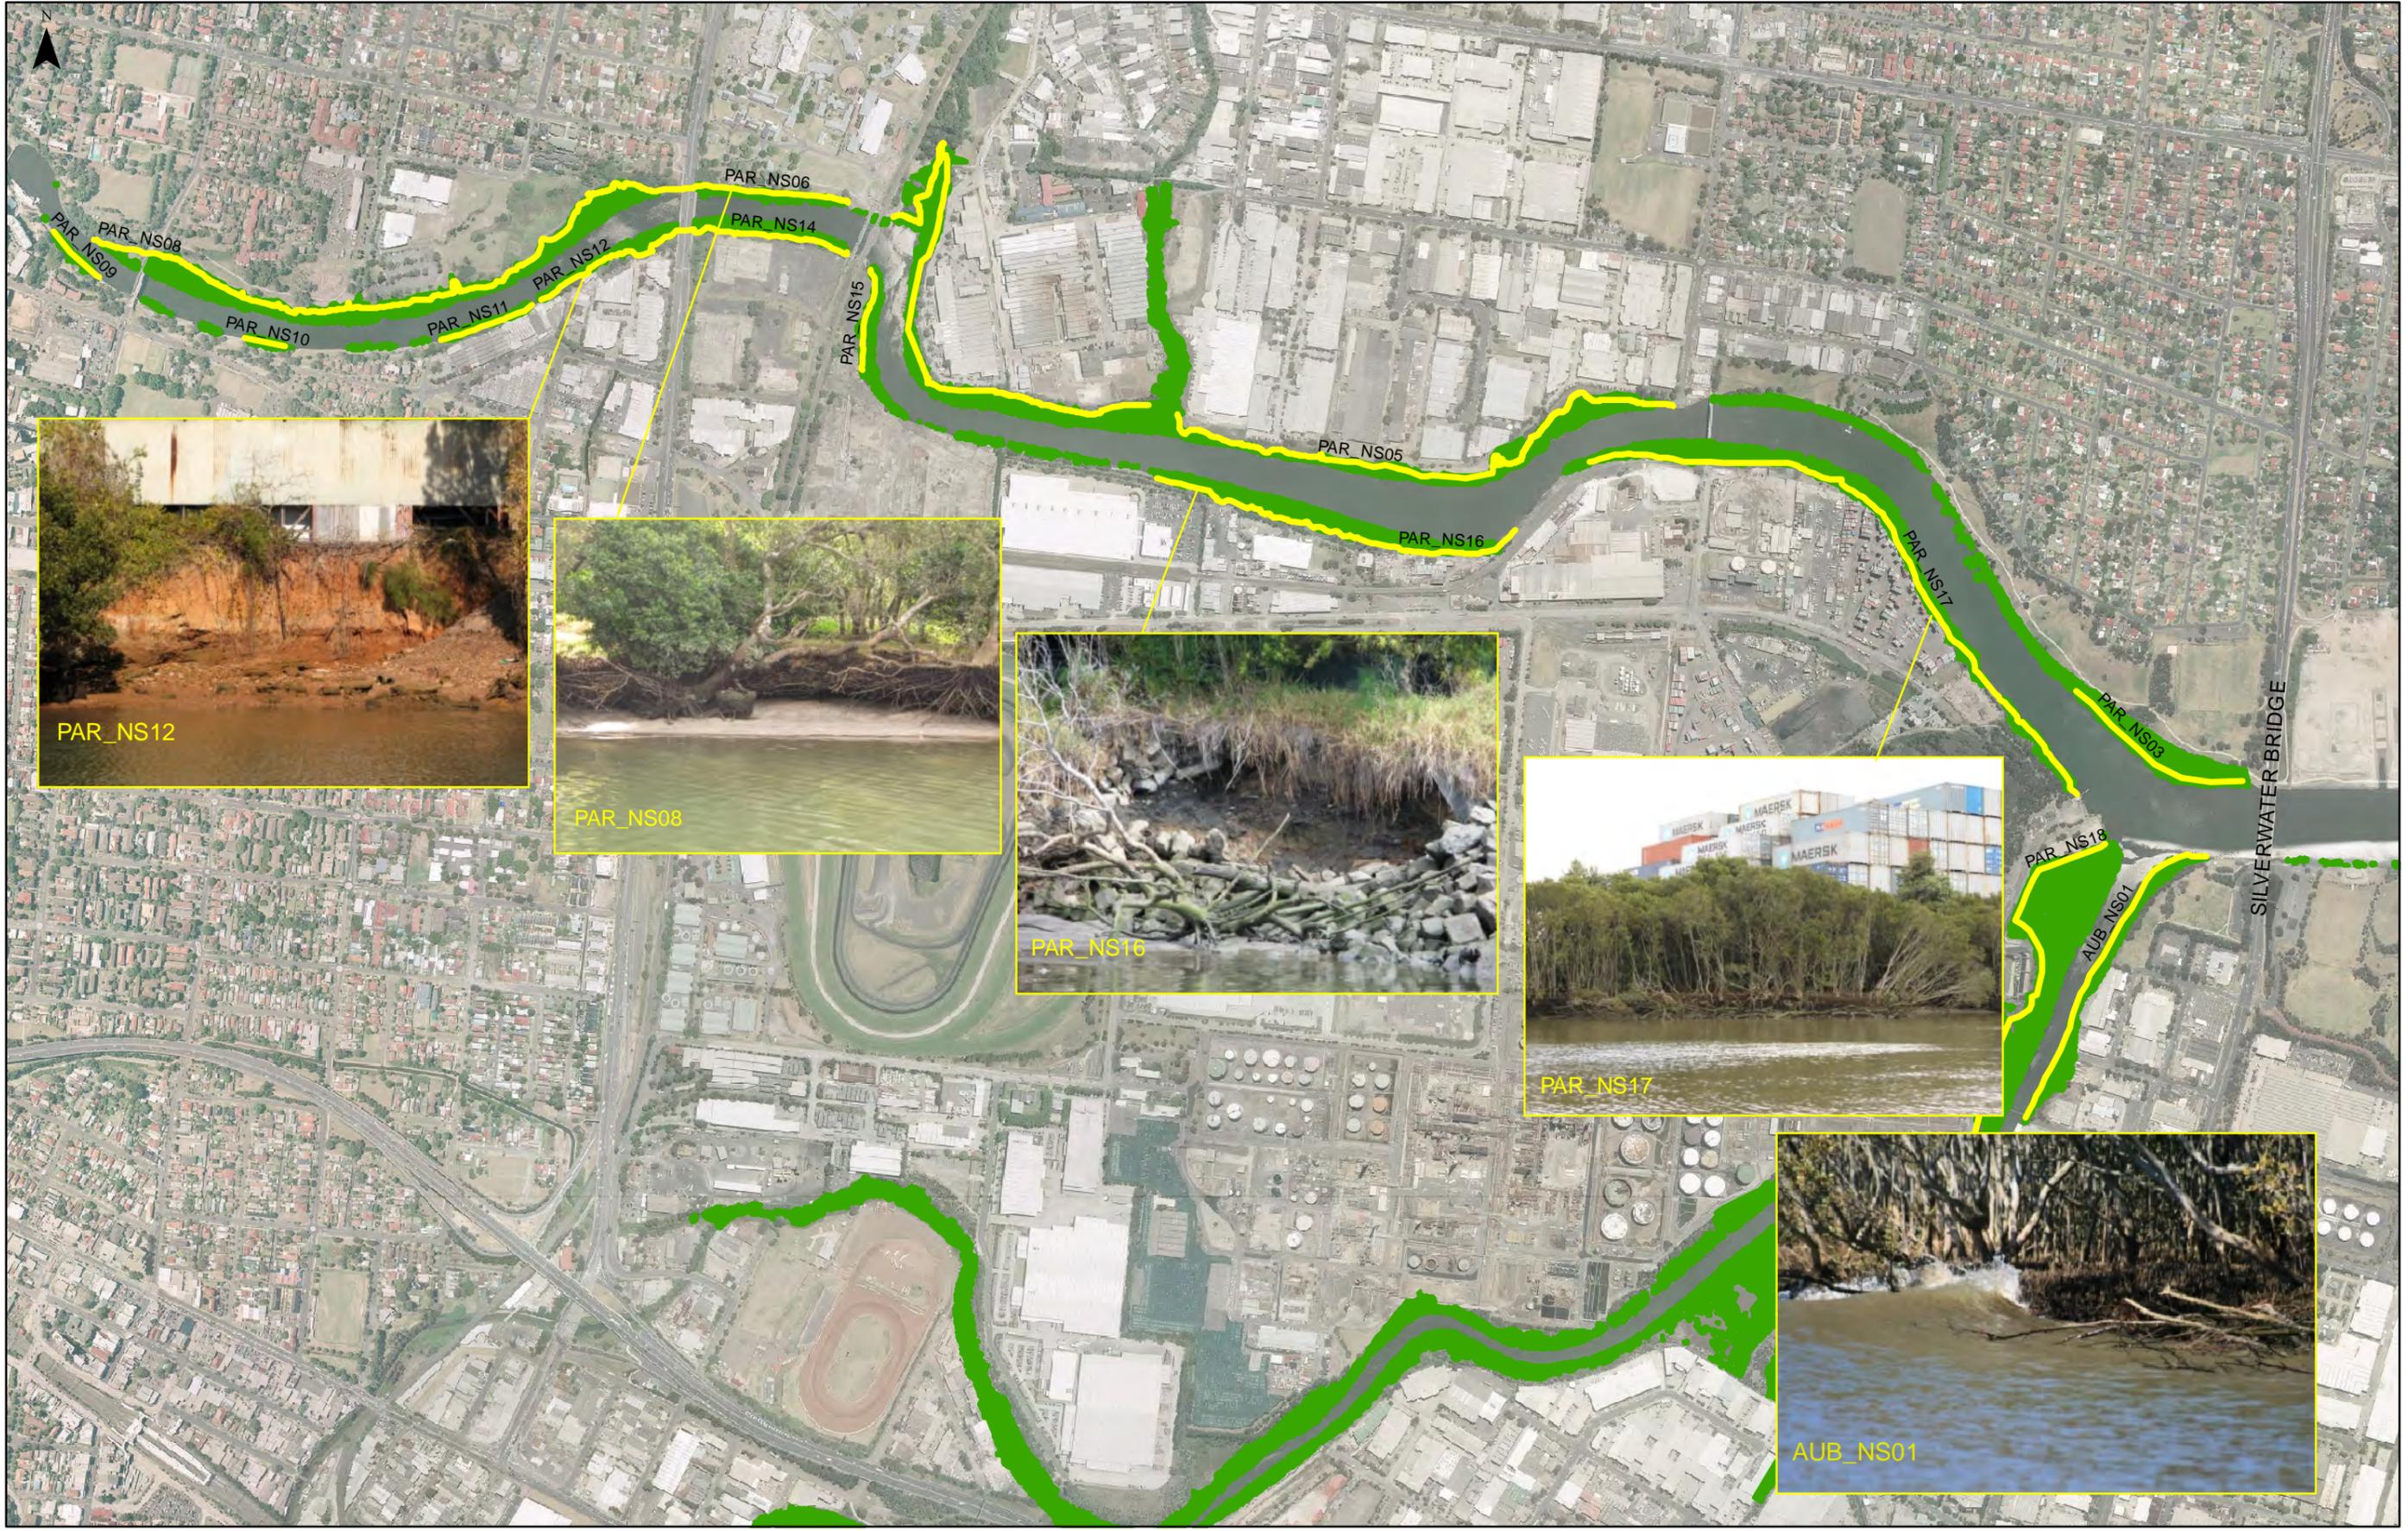
Approximately 70% (9.2 km) of shoreline exhibiting erosion is located upstream of Silverwater Bridge. This section of the river is characterised by a narrow channel, shallow water depths and banks vegetated with mangroves, and is subject to long wave durations from Rivercat movements.

The locations of erosion, upstream of Silverwater Bridge, are shown in Figure 5-7.

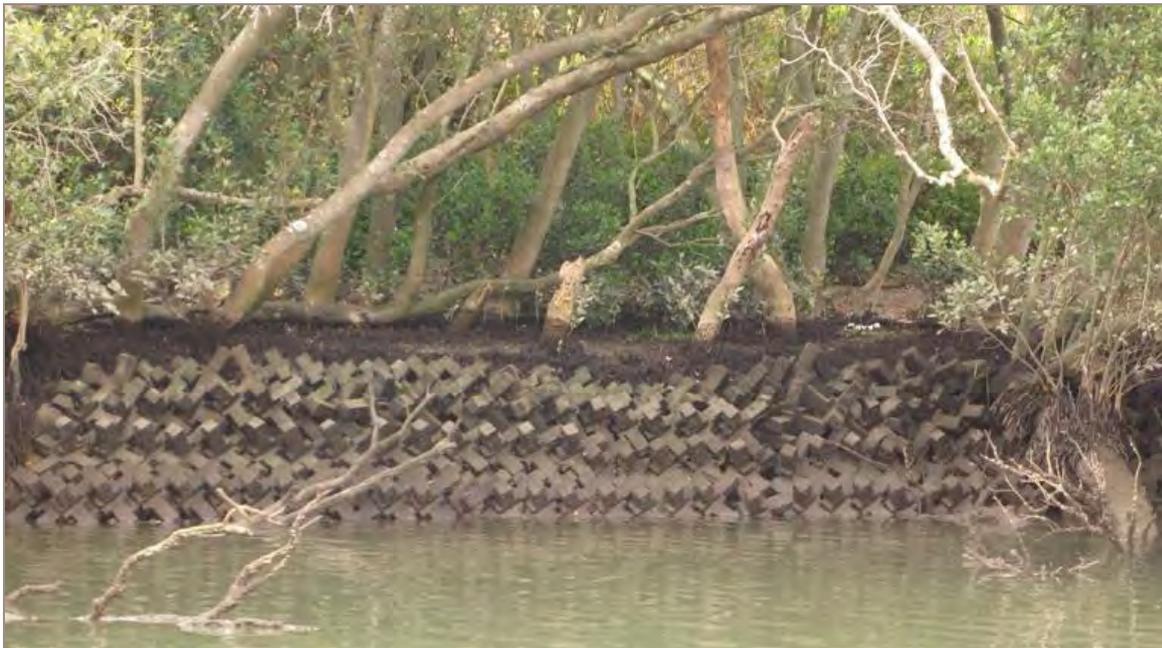
Figure 5-10. A-Jack units installed in front of mangroves on the Parramatta River upstream of Silverwater Bridge

This option has been employed at discrete locations upstream of Silverwater Bridge using A-Jack armour units (Figure 5-10). Prior to additional structures being recommended or installed, a detailed study of the performance of these existing structures should be undertaken. A-Jacks have also been used on the Coomera River in Queensland (Figure 5-11, Derbyshire 2006).
