PARRAMATTA RIVER ESTUARY DATA COMPILATION AND REVIEW STUDY

Report Prepared for

Parramatta City Council,
Department of Environment and Climate Change &
Sydney Metropolitan Catchment Management Authority:

On behalf of the
Parramatta River Estuary Management Committee

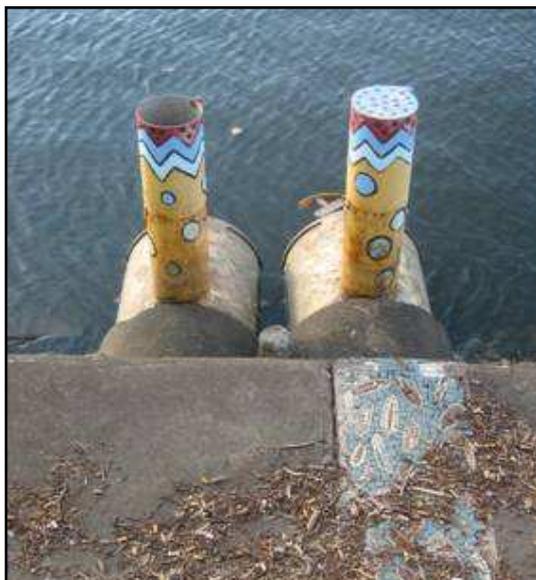
Stormwater Outlets into Iron Cove (4/3/2008)

The management of urban stormwater falls into two categories – quantity and quality. The quantity aspect of urban stormwater is managed by the provision of pipe networks, overland flow paths and open channels from urban areas to discharge to the estuary. Urban stormwater also delivers loads of litter and debris, nutrients, sediments and a range of contaminants to the estuaries. Controls on the loads take the form of WSUD features spread throughout the catchments. Stormwater quantity and quality within the catchment is generally managed by the various councils and Sydney Water Corporation.

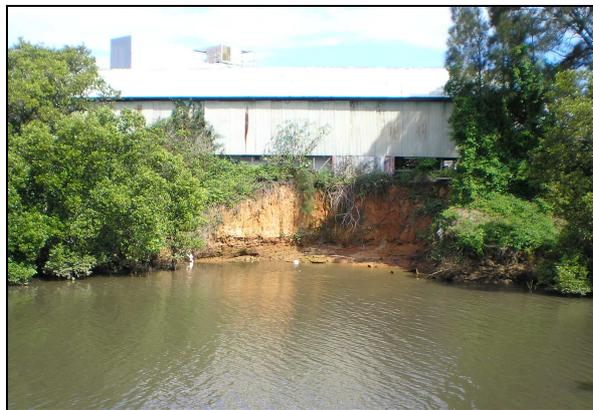
Bank Erosion – Upper Estuary (28/11/2007)

In general, it appears that bank erosion is an issue throughout the study area. This may be due to a range of factors. Bank erosion may have flow-on effects on a number of other features of the estuary and may pose a risk to public safety.

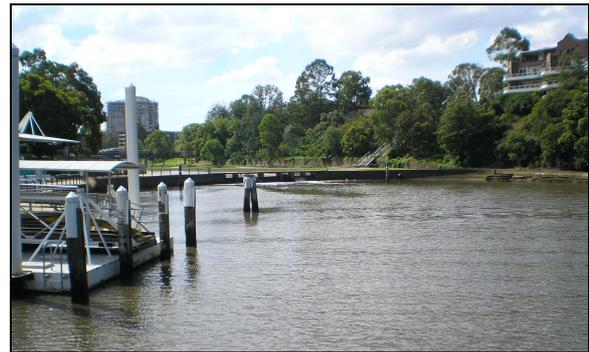
Charles Street Weir (28/11/2007)

Flood control, transport and water supply systems associated with the early settlement of the area have greatly altered the flow of the Parramatta River. Dredging for ferry access has also changed the natural channels of the river, altering the flow conditions. The Charles Street Weir is the limit of tidal influences on the main arm of the river.

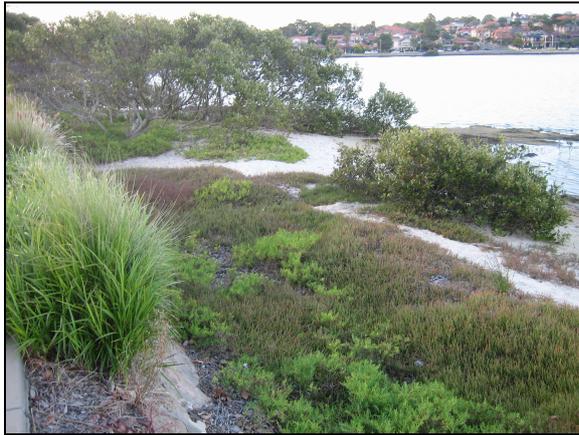
**Mangroves and Saltmarsh in Iron Cove
(4/3/2008)**

NSW DPI – Fisheries, in partnership with the SMCMA, NSW Maritime and the Royal Botanic Gardens have recently mapped aquatic flora for the Parramatta River Estuary. The mapping was undertaken for mangroves, saltmarsh, seagrass and kelp.

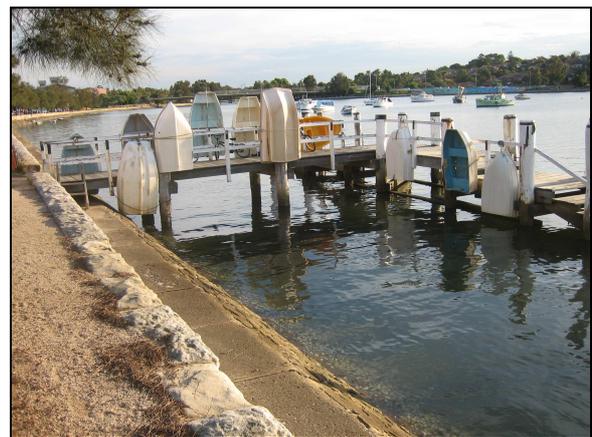
**Dinghy Storage and Boat Access
(Iron Cove, 4/3/08)**

Numerous foreshore and waterway facilities cater for the recreational demand on the estuary. However, the required facilities do not fulfil the demand in some areas and human usage of the estuary often conflicts with other estuarine processes (such as ecology and water quality).
