# PARRAMATTA RIVER

Swim Site Activation Framework

Project Client: Parramatta River Catchment Group  
Project Name: PARRAMATTA SWIM ACTIVATION FRAMEWORK  
Project Number: 575SL

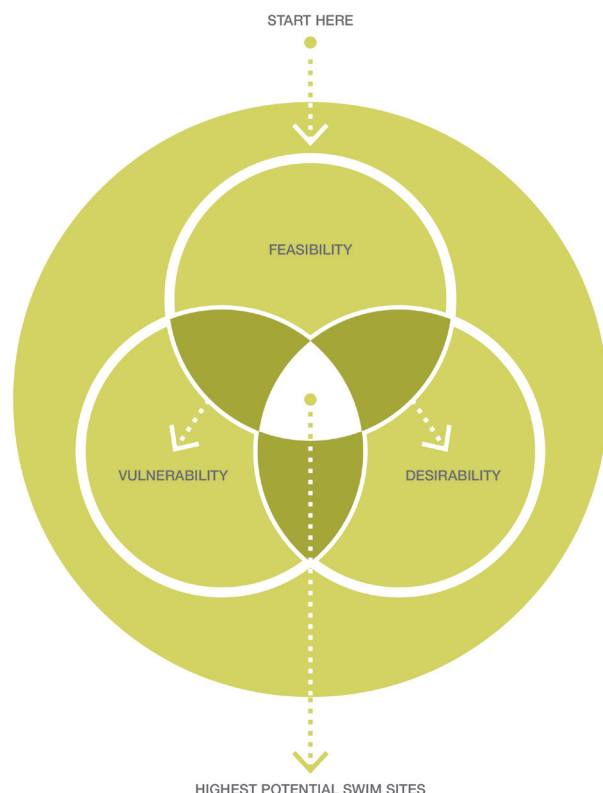
Diagram 1: Site Activation Framework Process

The following provides an overview of how the criteria are applied to assess a potential swim site.

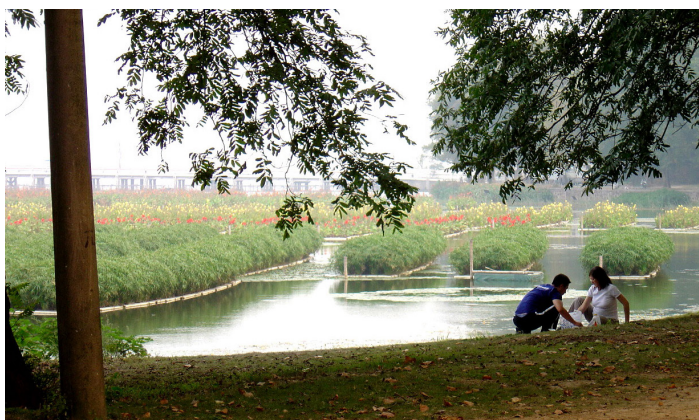
Floating Wetlands  
Aqua Biofilter, Lake Taihu

Lake Taihu Aqua Biofilter is a floating wetland used to treat wastewater. The system is composed of reed islands that are interspersed with Canna lilies, a popular crop for animal feed. The project has restored healthy biological activity to the lake while also providing a new local industry.

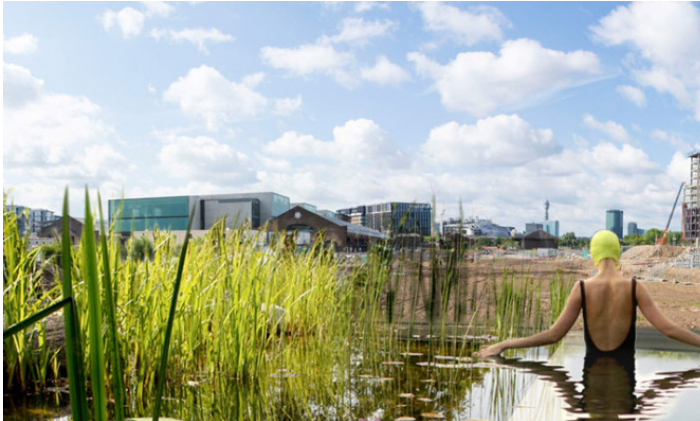
Natural Filtration  
Kings Cross Pond Club, London

Kings Cross Pond Club is a 40-metre-long natural swimming pool. The pool purifies the water using a chemical free approach. Pools are divided into recreational swim zones and filtration zones. Floating and underwater plants oxygenate and cleanse the water.

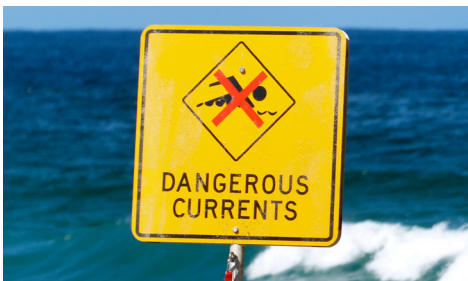
Dangerous Current Hazard signs  
Royal Life Saving NSW

Hazard signs are deployed by Royal Life Saving NSW in order to protect swimmers from dangerous currents.

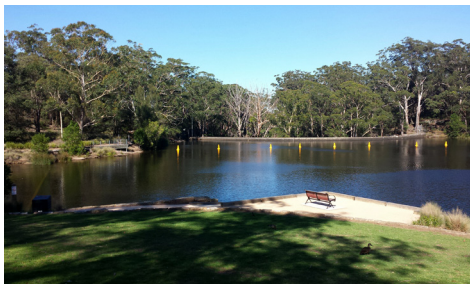
Hazard Dive  
Lake Parramatta, Sydney

Lake Parramatta is a swim site located two kilometres from Parramatta CBD, a highly urbanised area. A series of dives took place and potential hazards were cleared to ensure that the site is safe for swimming.

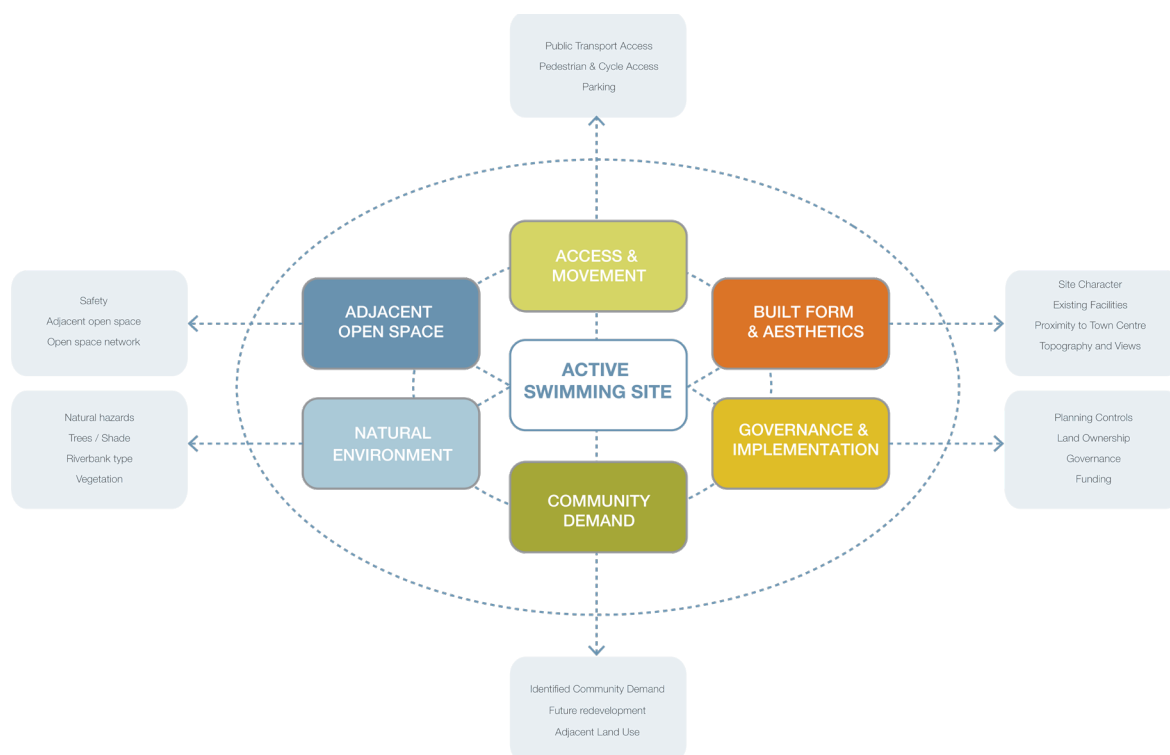
Diagram 3: Desirability criteria

- Identified Community Demand
- Future Redevelopment
- Adjacent Land Use

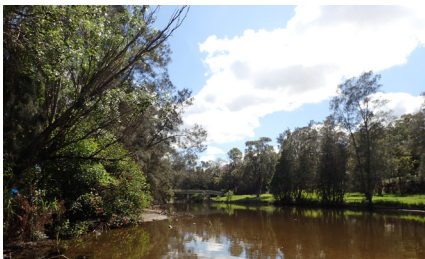
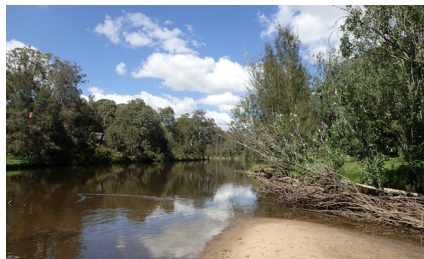
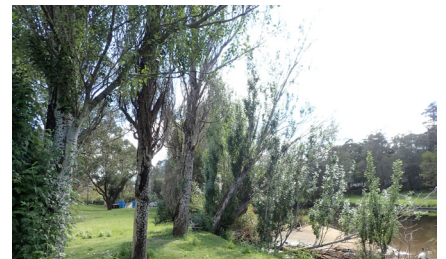
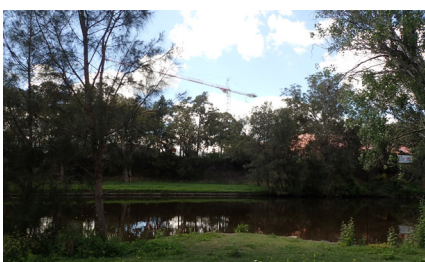
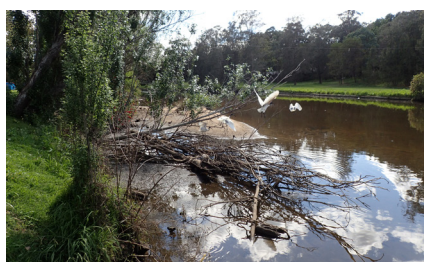
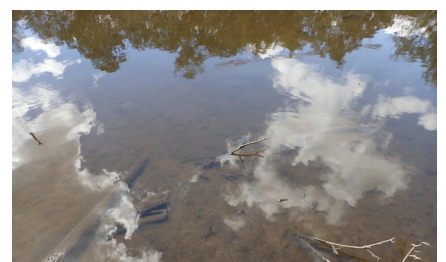
During the site visit the visible water quality was reasonably good. It is recommended to undertake screening water quality monitoring (and exposure pathway analysis for chemicals and pathogens) at the site during dry weather to understand the water quality. Depending on the outcomes of this, further investigations into the viability of swimming at the site could be considered.

An initial feasibility assessment has been undertaken for Little Coogee based on information and knowledge of the site at present. While full water quality data is not available for Little Coogee, initial water quality monitoring conducted by City of Parramatta showed that Little Coogee is comparative to water quality in the CBD, albeit slightly better. Little Coogee is currently considered feasible for land-based activation and is likely to be suitable for splash contact activation. Water quality monitoring is recommended to understand potential for swim based activation, but based on information available at present it is considered unlikely to be feasible for swimming. A treated water river swimming site is considered feasible at the site based on the available land and previous studies which have investigated this along the river foreshore.

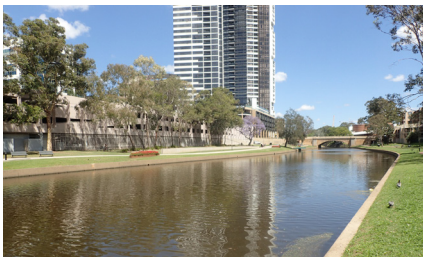
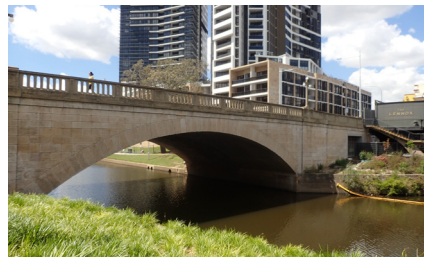
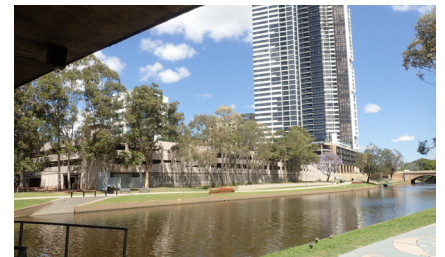
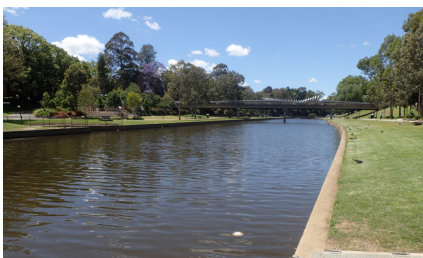
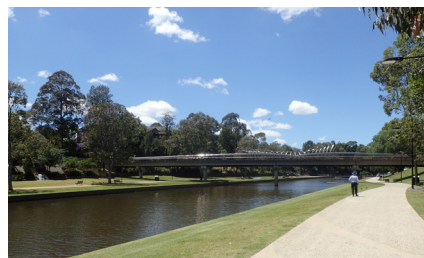
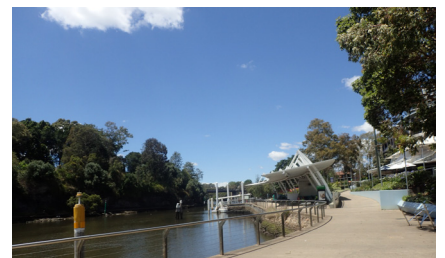
An initial feasibility assessment has been undertaken for Parramatta CBD based on information and knowledge of the site at present (water quality data is available for the site). The CBD is currently considered feasible for land based activation and splash contact activation and both are presently occurring at the site. Water quality monitoring undertaken to date by the City of Parramatta indicates that the site is currently not feasible for swimming. A swim site is considered desirable in the Parramatta CBD and a treated water swim site is considered feasible at the site based on the available land and previous studies which have investigated this along the river foreshore.

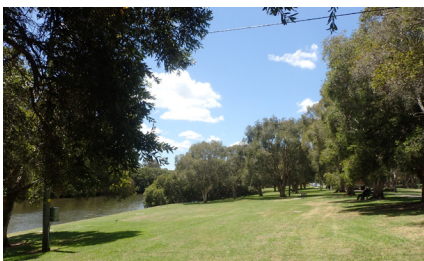
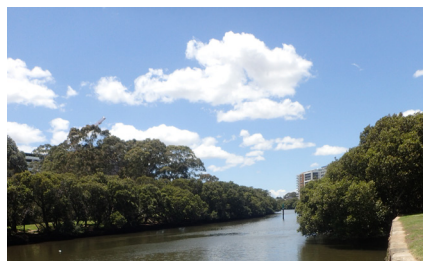
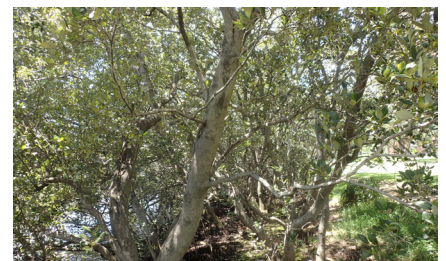
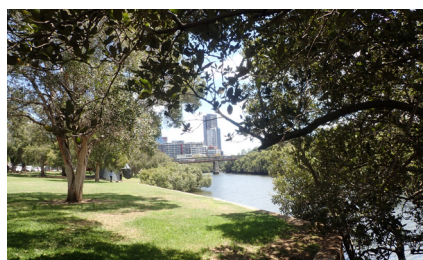
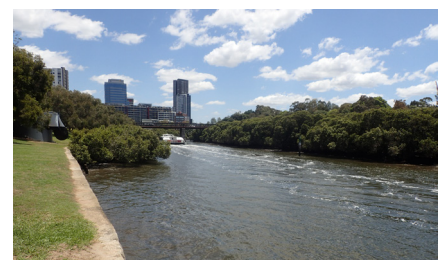
An initial feasibility assessment has been undertaken for Macarthur Street based on information and knowledge of the site at present (no water quality data is available for the site). The site is currently considered feasible for land based activation. The vertical sea wall combined with proximity to the Rivercat route limits options for in-river based activity. There are potential opportunities to increase engagement with the river through the creation of a floating type platform to provide access to the river's edge, which could be used for fishing, boat launching and similar activities.

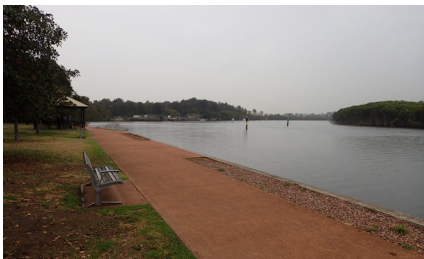
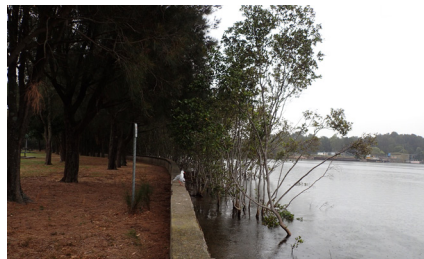
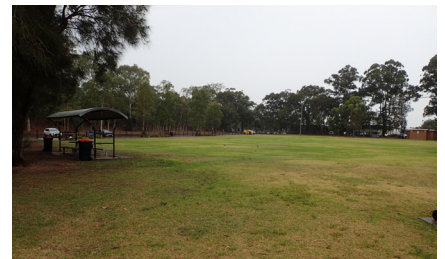
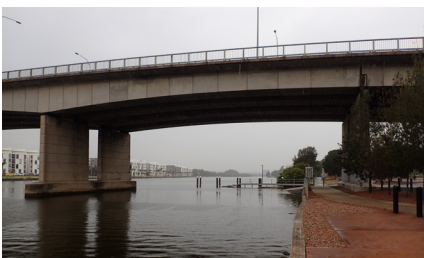
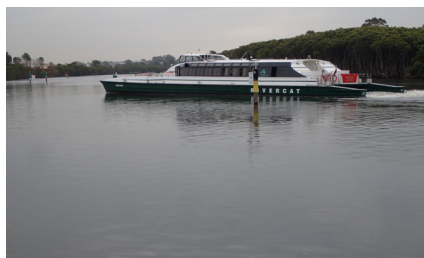
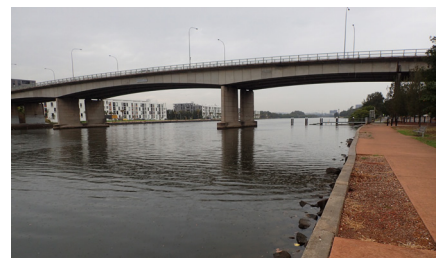
An initial feasibility assessment has been undertaken for Silverwater Park based on information and knowledge of the site at present (including preliminary water quality data available for the site). The preliminary water quality results to date show that enterococci levels during dry weather are below the recommended threshold for swimming. However, during and shortly after rain events, even relatively small rain events, the enterococci levels are very high. Furthermore, the site is located downstream of industrial development and adjacent to former historical heavy industry, resulting in the potential for poor river sediment quality. The site is also located close to the ferry route which passes in close proximity to the river edge.

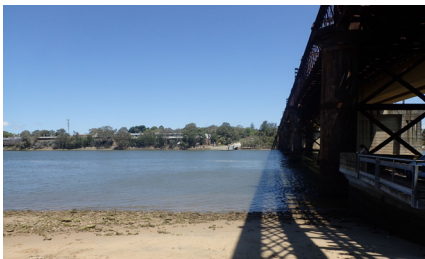
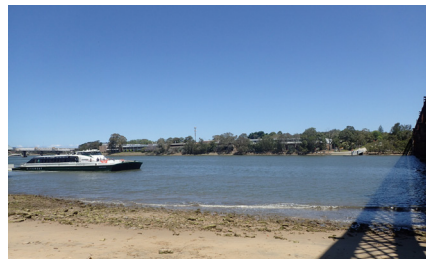
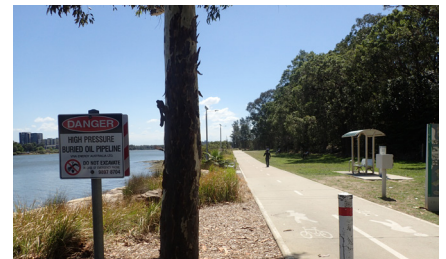
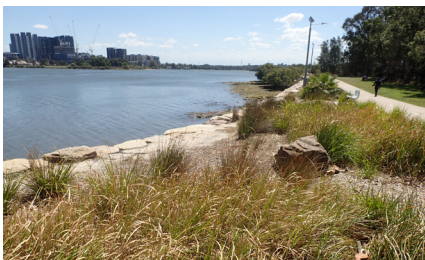
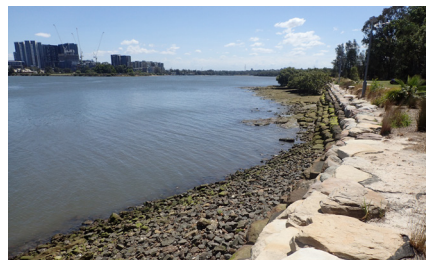
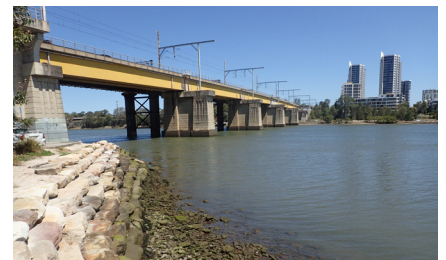
An initial feasibility assessment has been undertaken for Meadowbank Baths based on information and knowledge of the site at present (no water quality data is available for the site). The current site has steep vertical edges and a rocky substrate which is in close proximity to the ferry route. Furthermore the site is located opposite to historical heavy industry resulting in the potential for poor river sediment quality. The Rivercat ferry passes in close proximity to the site. The river edge has limited access due to a sea wall and rocky substrate. The site is currently considered feasible for land-based activation although with active interventions to the river edge to provide access to the water, splash contact could also be suitable. A swim site could be suitable in the future depending on water quality and through interventions such as re-construction of the former baths or similar.

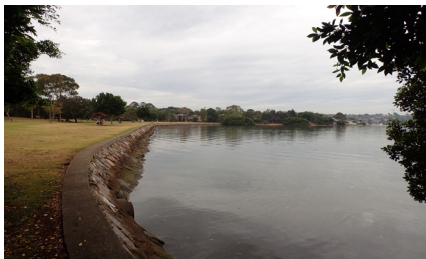
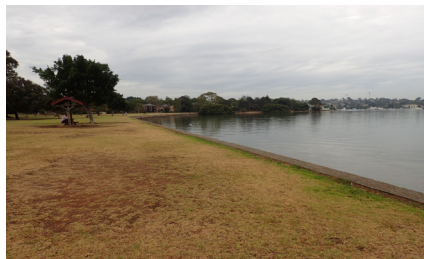
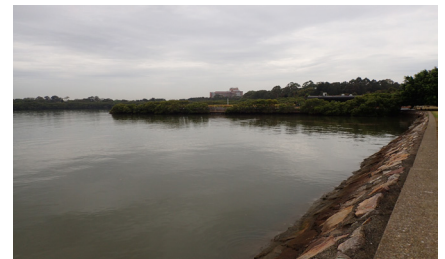
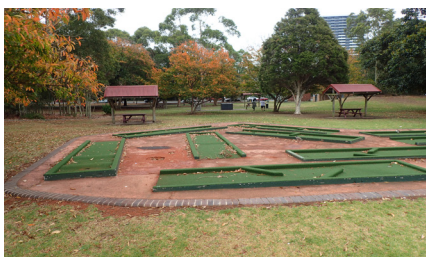
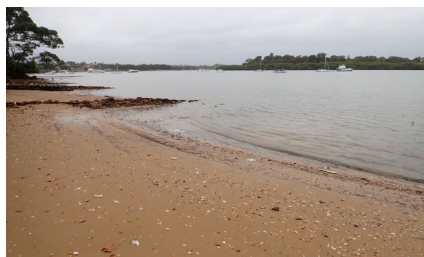
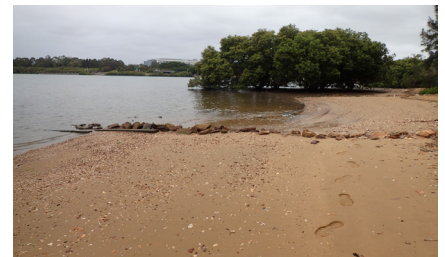
An initial feasibility assessment has been undertaken for Brays Bay Reserve based on information and knowledge of the site at present. The City of Canada Bay Council took one sample of water quality as a 'very quick screen'. The current site has steep vertical edges which currently prevents access to the river's edge. The site is currently considered feasible for land-based activation. With active interventions to the river edge to provide access to the water and protection from the ferry, the site could also be suitable for splash contact. Bathymetry data shows that the water depth is shallow close to the edges of the bay and any swim site would require wharf or jetty type structures to provide access to the deeper sections of the bay. A swim site could be suitable in the future depending on water quality results and combined with interventions such as re-construction of a jetty/pier or similar.

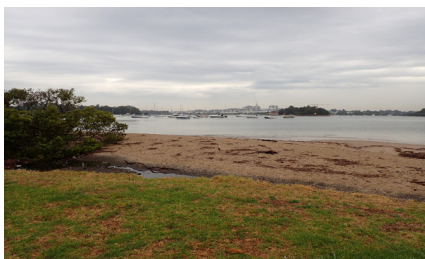
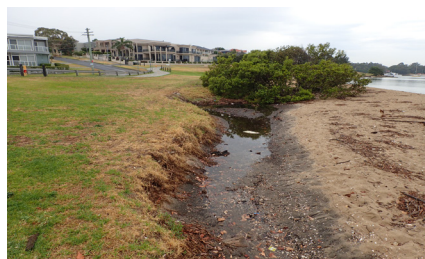
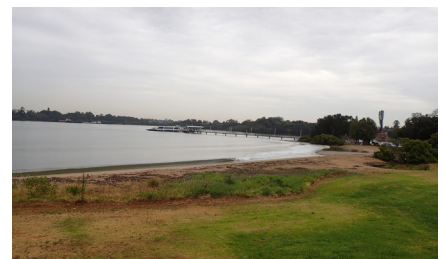
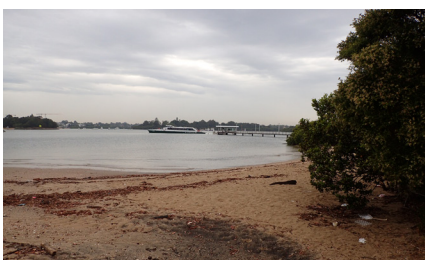
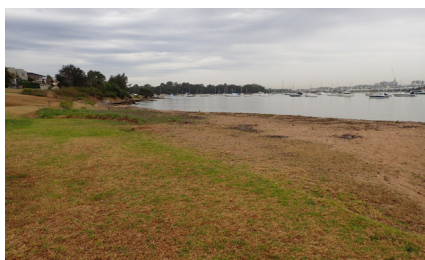
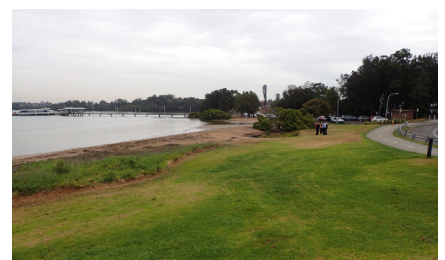
An initial feasibility assessment has been undertaken for Kissing Point Park based on information and knowledge of the site at present (no water quality data is available for the site). The current site has good access to the water's edge and a sandy beach area. The site is currently considered feasible for land based activation and splash contact. Observations at low tide show that the water depth is very shallow for significant distances (50 to 100m) and hence any swim site would need to be located a significant distance from the shore. A floating pontoon could be a potential swim site activation at the site in the future.

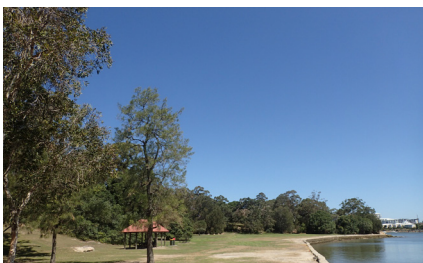
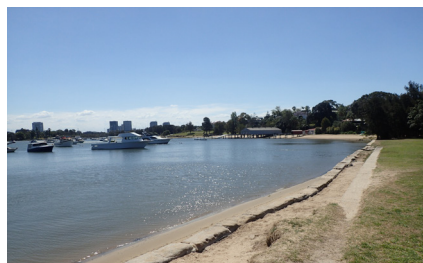
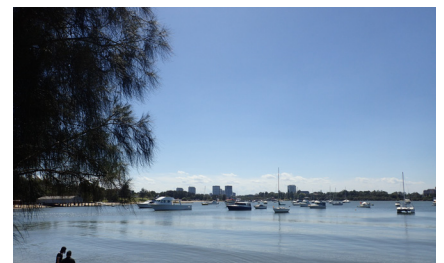
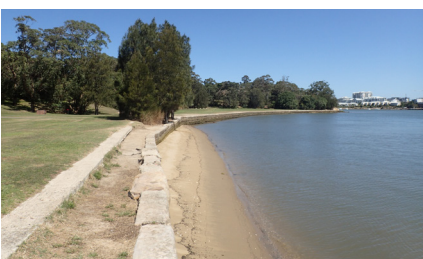
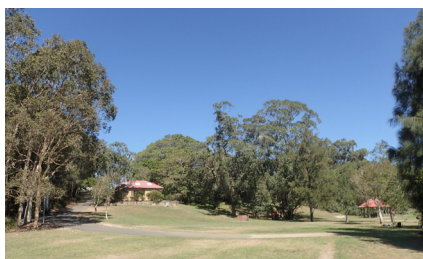
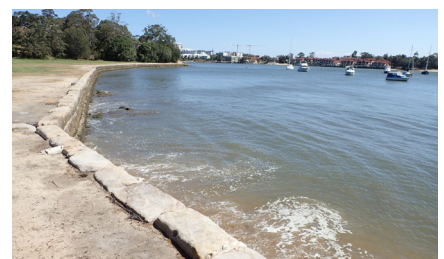
An initial feasibility assessment has been undertaken for Putney Park based on information and knowledge of the site at present (no water quality data is available for the site). The current site has limited access to the water's edge due to the steep vertical sea walls. At the base of the sea wall is a sandy beach area exposed at low tide. The site is currently considered feasible for land based activation and splash contact. Opportunities for splash contact could be easily improved through improved access to the river's edge. A swim site could be suitable in the future depending on water quality results and further consideration of defined zones which delineate private boat traffic zones and swimming areas.

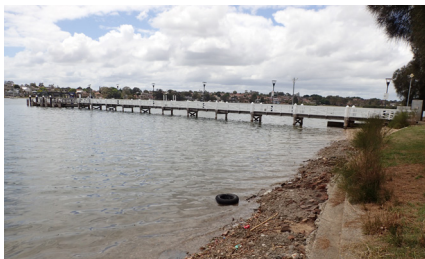
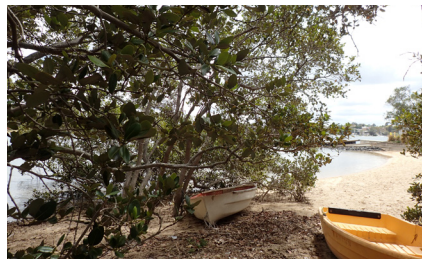
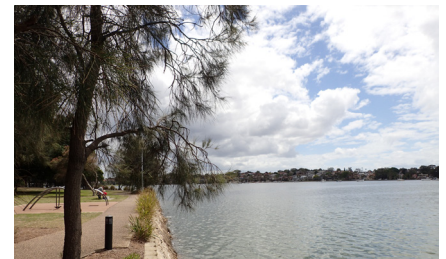
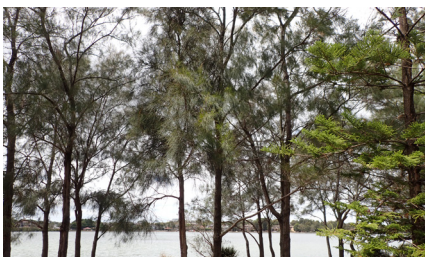
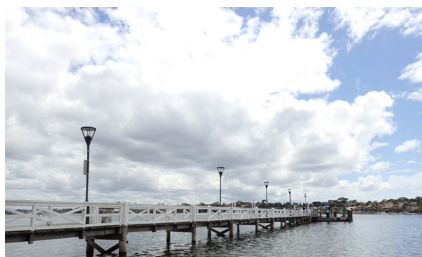
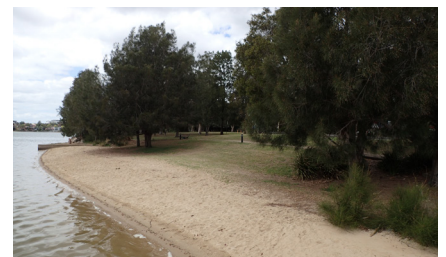
An initial feasibility assessment has been undertaken for Bayview Park based on information and knowledge of the site at present (no water quality data is available for the site). The current site has good access to the river's edge with a sandy beach area. The site has a ferry stop and proximity to the route for the ferry needs to be considered in future activation. The site is currently considered feasible for land based activation and splash contact. The site would also be suitable for swimming with minimal interventions depending on water quality results and defining a swimming area separate from the ferry route.

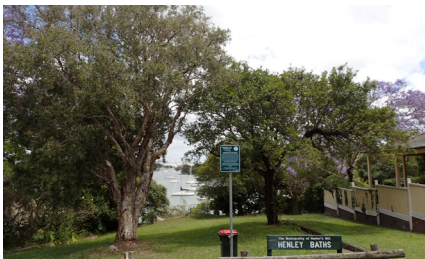
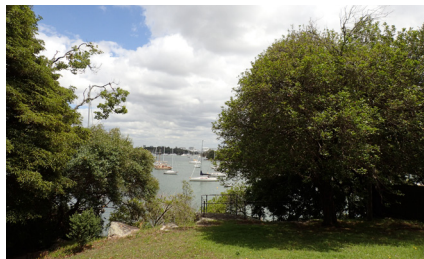
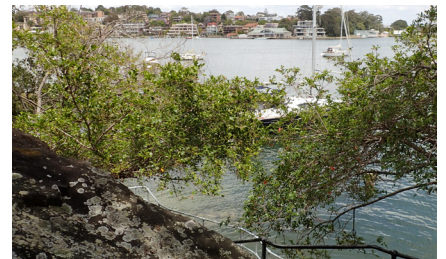
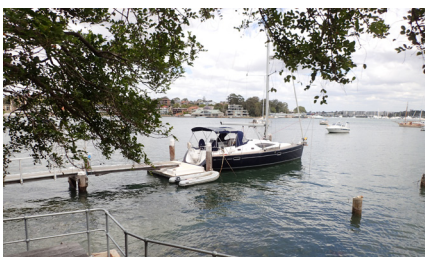
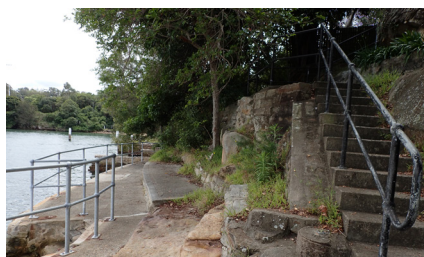
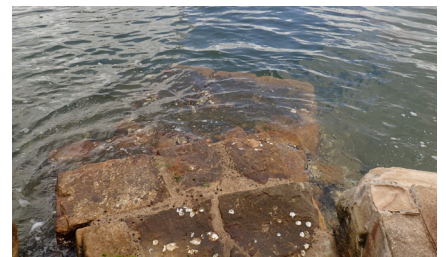
An initial feasibility assessment has been undertaken for Henley Baths based on information and knowledge of the site at present (no water quality data is available for the site). The current site has reasonable access to the water's edge with steps down to the water through a natural cliff line. The site has a lot of private boat traffic that needs to be separated from any swim areas. The site has a rocky base with oysters and other natural hazards that needs to be considered. The site is currently considered feasible for land based activation and splash contact. The site would also be suitable for swimming with minimal interventions depending on water quality results. The key limitation of the site is the limited space available both at the river's edge and the land, and would only be suitable for limited use at any one time, making it a local site.

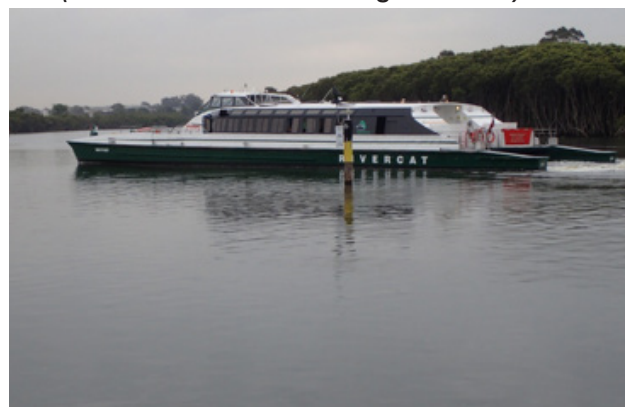
1. Splash water play – A new playground which creates play spaces over and on the river while reducing immersive contact with the river water. The contact would be similar to secondary contact recreation activities. The water play space is protected from contact with the ferry by a timber boardwalk and balustrade and protected from the ferry wash by rock surrounds which also serve as ecological elements (**items 5, 6 & 7 on the sketch design overleaf**)
2. Boat Hire – a boat ramp on the left side of the timber deck allows for the launch of boats onto Duck River/Parramatta River. This would require a change to the current restrictions of watercraft west of the Silverwater Bridge. In particular, as Duck River is not affected by the Rivercat it would seem initially feasible to allow kayaking up Duck River. (**item 1 on the sketch design overleaf**)

3. Ecological play – Through creating a new ecological foreshore there are opportunities to create new elements of interaction along the riverbank. Similar to the way that rock platforms are explored by all ages at the beach, it is proposed to create new ecological elements which also provide interesting places to explore along the water's edge. **(item 3 on the sketch design overleaf)**

Given the above vulnerabilities, a site strategy was developed, which focussed on secondary contact. Three ways of engaging with water and activating the site for greater river based recreation have been identified:

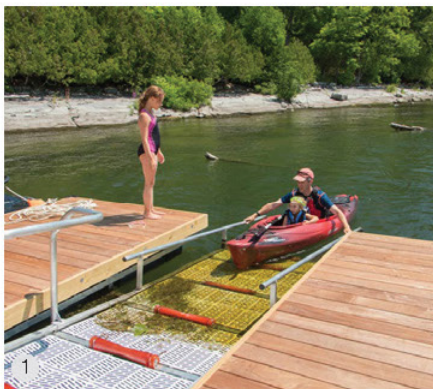
1. Boat hire
2. Open play lawn
3. Native grasses
4. BBQ's + shade structures for large groups
5. Water play
6. Water play
7. Water play
8. Change/toilet + bike hire

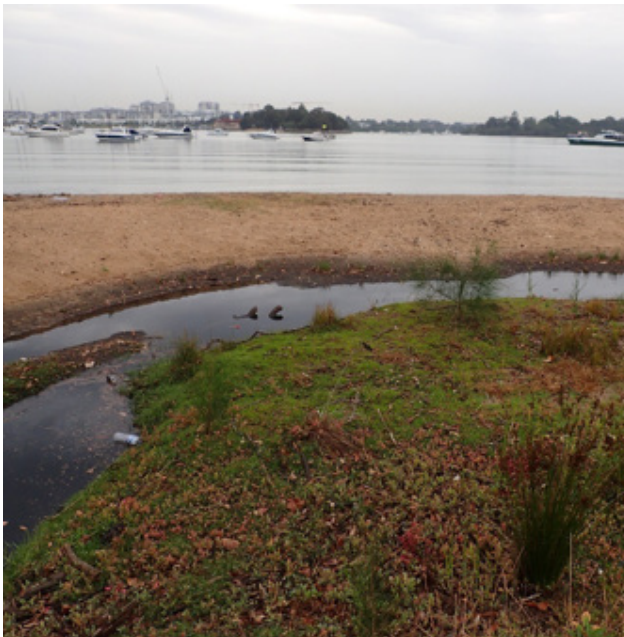
Figure: Stormwater outlet reducing access to and amenity of the beach

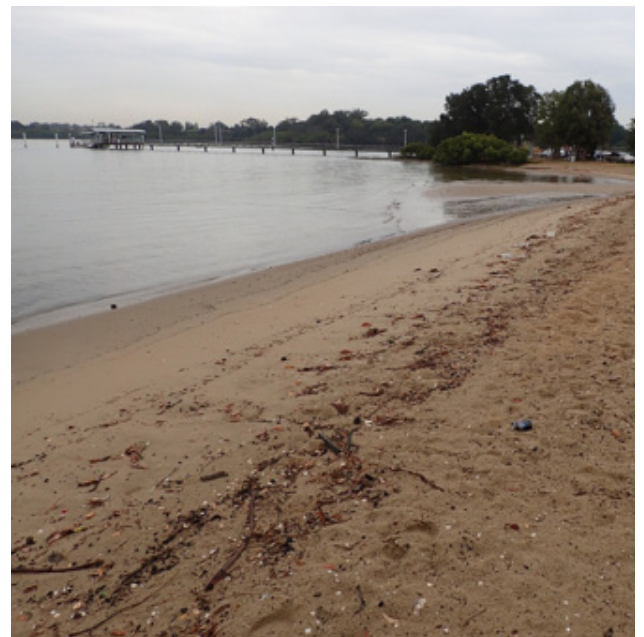
Figure: Sandy bed of the river becoming exposed (mid-tide)

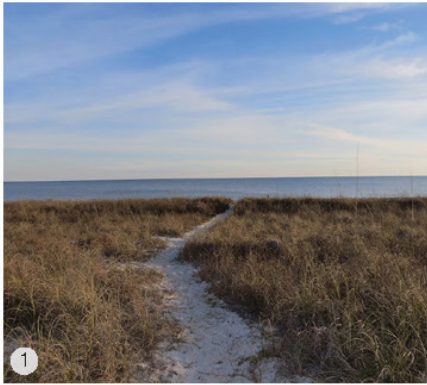
1. Infiltration zone
2. The beach
3. Riparian planting to bank
4. Timber deck + boardwalk
5. Concrete wall edge
6. Retained salt marsh
7. Lawn
8. Concrete path

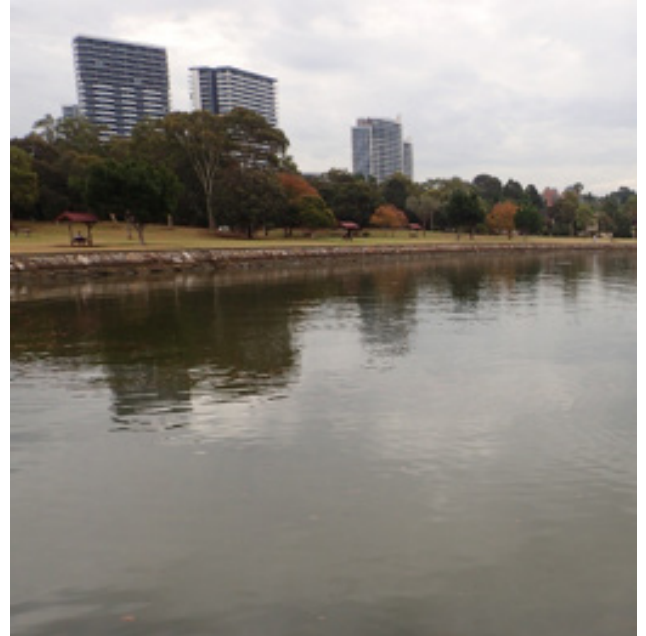
Figure: Existing Brays bay Reserve foreshore with development of Rhodes West in background

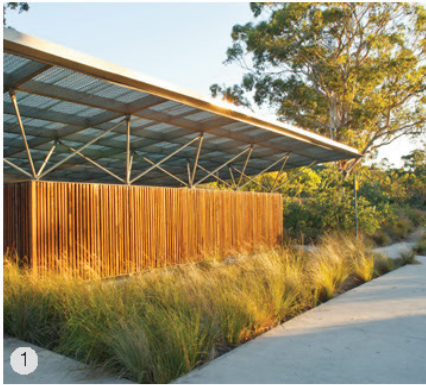
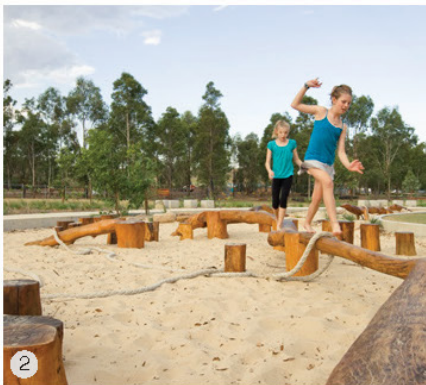
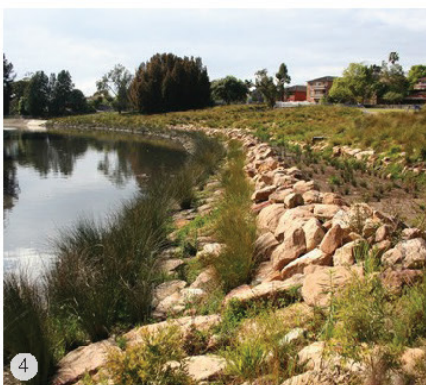
1. Entry plaza + building (toilet/changerooms)
2. Childrens play with shade structure + BBQ's
3. Entry plaza
4. Planted seawall edge cleans all water entering bay
5. Pool/deck + access
6. Marine ecological zone + water filter
7. New mangroves planting
8. Shade structures + BBQ's for large groups

A strategy has also been developed for the site which uses a natural treatment system to treat the water flowing through the pool. It is proposed that all water entering the pool would flow through a sea grass and mangrove treatment system integrated into the foreshore. Research of natural sea grass meadows (Lamb et. Al, (2017), Science 355: 6326) found that there was a 50% reduction in the abundance of pathogens when seagrass meadows were present. This system would therefore provide both for new ecological habitat as well as a natural treatment system for the pool.

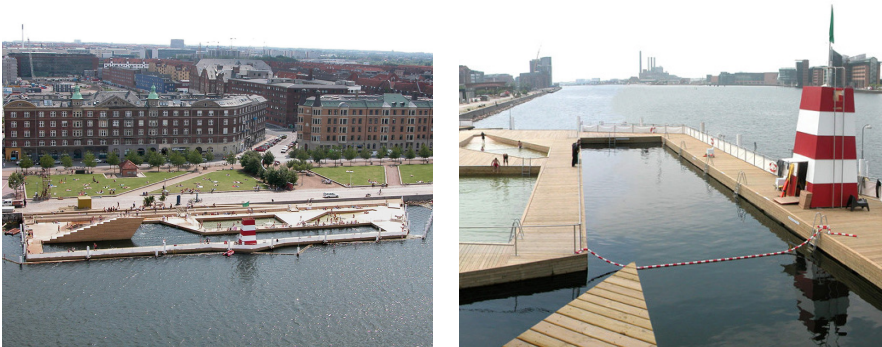
### COPENHAGEN HARBOUR BATHS

**Precedent** River pool in a prominent location

Size total area of 2500 m<sup>2</sup>

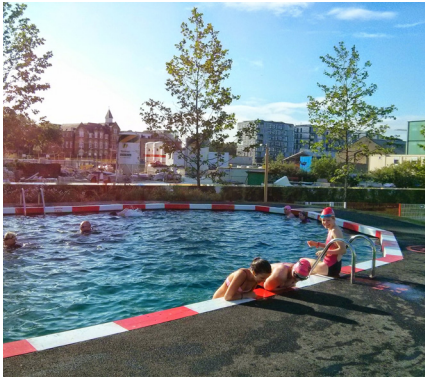
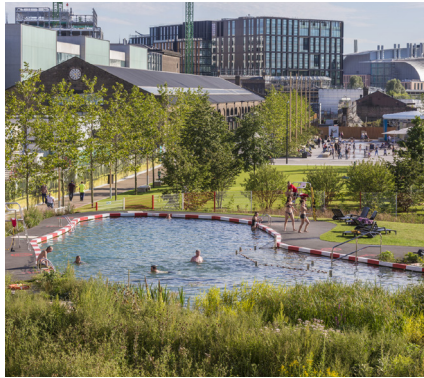
'OF SOIL AND WATER': KINGS CROSS POND CLUB

**Precedent** Naturally-purified swimming pool by a commercial operator

**Size** 40m long - space for 40 bathers, total area of 2200m<sup>2</sup>

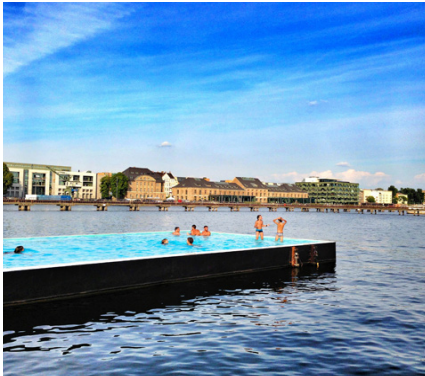
BADESCHIFF

**Precedent** Swimming pool 'within' the river, where water quality is not suitable

**Size** 32m long

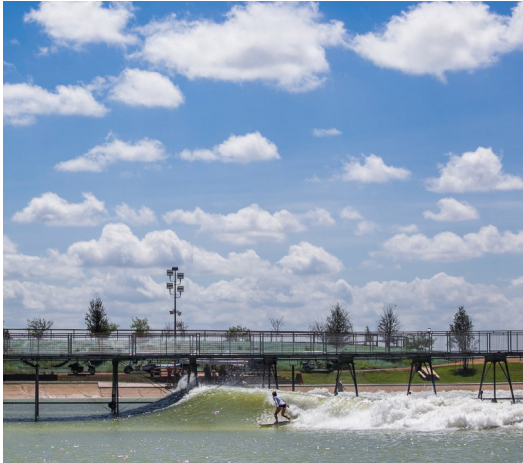
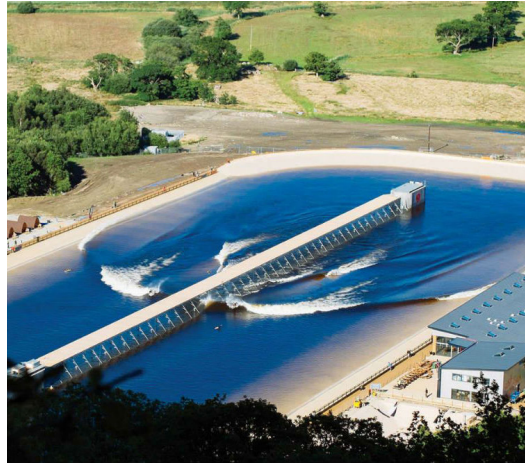
NLANDS SURF PARK

**Precedent** Treated stormwater used for inland surfing and recreation by the community.

**Size** 5.5 hectares
