# PARRAMATTA RIVER

Swim Site Activation Framework

Project Client: Parramatta River Catchment Group  
Project Name: PARRAMATTA SWIM ACTIVATION FRAMEWORK  
Project Number: 575SL

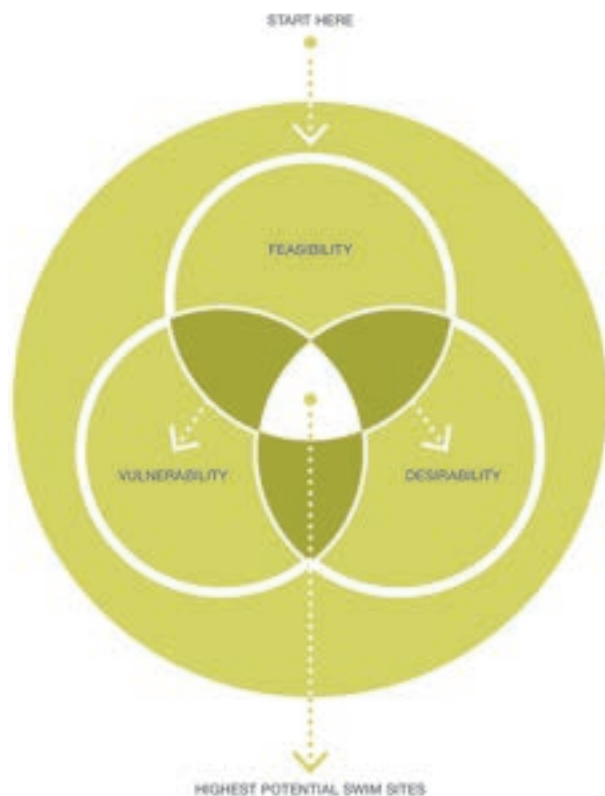
Diagram 1: Site Activation Framework Process

The following provides an overview of how the criteria are applied to assess a potential swim site.

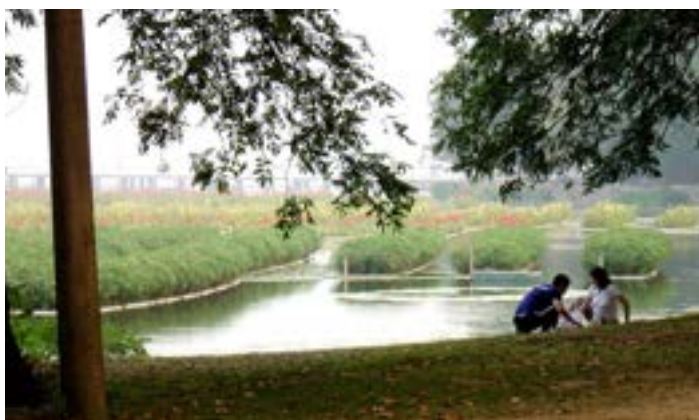
Floating Wetlands  
Aqua Biofilter, Lake Taihu

Lake Taihu Aqua Biofilter is a floating wetland used to treat wastewater. The system is composed of reed islands that are interspersed with Canna lilies, a popular crop for animal feed. The project has restored healthy biological activity to the lake while also providing a new local industry.

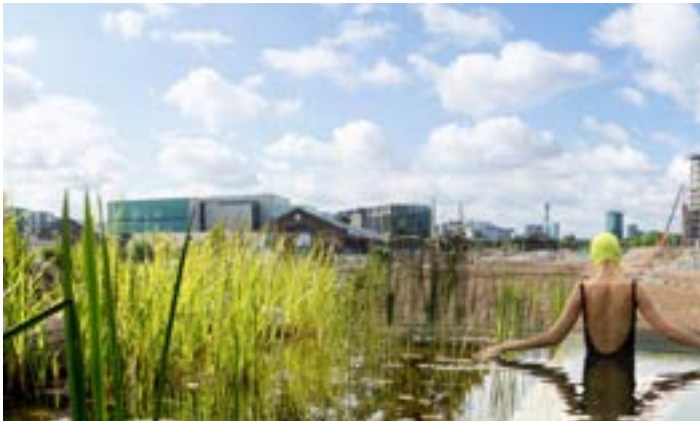
Natural Filtration  
Kings Cross Pond Club, London

Kings Cross Pond Club is a 40-metre-long natural swimming pool. The pool purifies the water using a chemical free approach. Pools are divided into recreational swim zones and filtration zones. Floating and underwater plants oxygenate and cleanse the water.

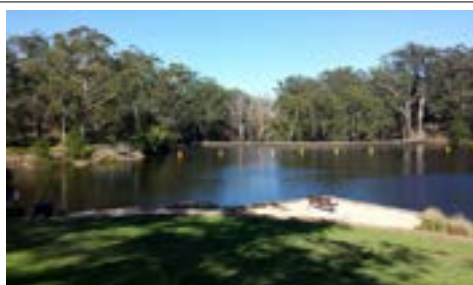
Hazard Dive  
Lake Parramatta, Sydney

Lake Parramatta is a swim site located two kilometres from Parramatta CBD, a highly urbanised area. A series of dives took place and potential hazards were cleared to ensure that the site is safe for swimming.

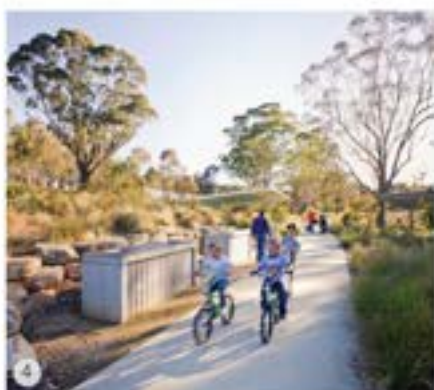
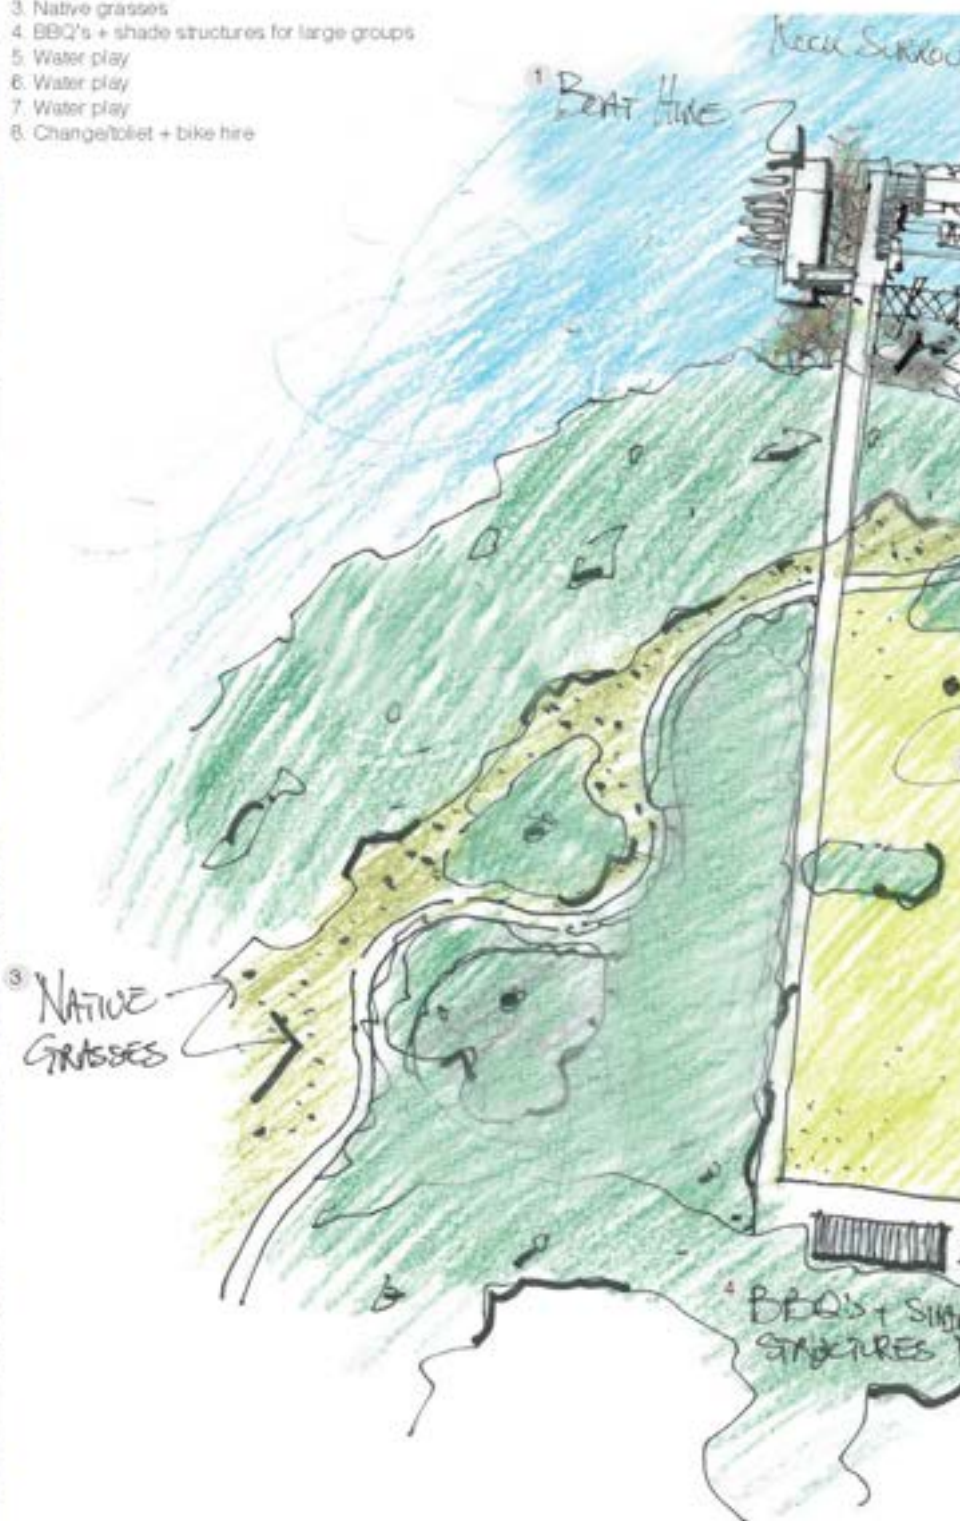
1. Boat hire
2. Open play lawn
3. Native grasses
4. BBQ's + shade structures for large groups
5. Water play
6. Water play
7. Water play
8. Change/toilet + bike hire

1. Splash water play – A new playground which creates play spaces over and on the river while reducing immersive contact with the river water. The contact would be similar to secondary contact recreation activities. The water play space is protected from contact with the ferry by a timber boardwalk and balustrade and protected from the ferry wash by rock surrounds which also serve as ecological elements (**items 5, 6 & 7 on the sketch design overleaf**)
2. Boat Hire – a boat ramp on the left side of the timber deck allows for the launch of boats onto Duck River/Parramatta River. This would require a change to the current restrictions of watercraft west of the Silverwater Bridge. In particular, as Duck River is not affected by the Rivercat it would seem initially feasible to allow kayaking up Duck River. (**item 1 on the sketch design overleaf**)

3. Ecological play – Through creating a new ecological foreshore there are opportunities to create new elements of interaction along the riverbank. Similar to the way that rock platforms are explored by all ages at the beach, it is proposed to create new ecological elements which also provide interesting places to explore along the water's edge. **(item 3 on the sketch design overleaf)**

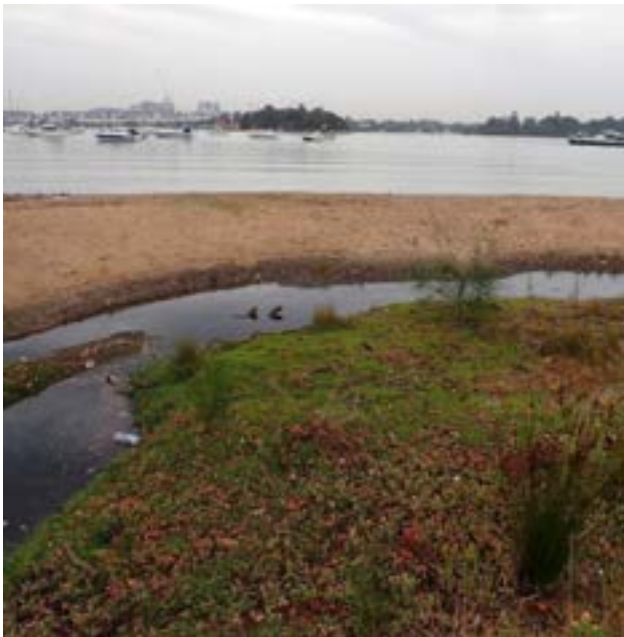
Figure: Stormwater outlet reducing access to and amenity of the beach

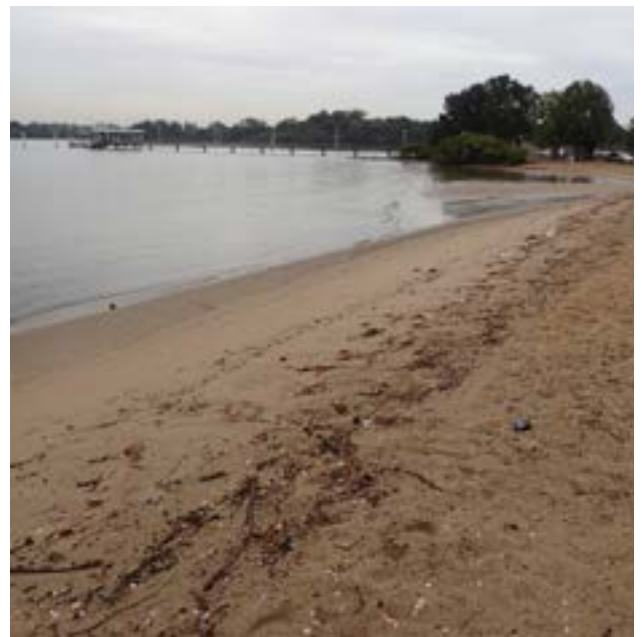
Figure: Sandy bed of the river becoming exposed (mid-tide)

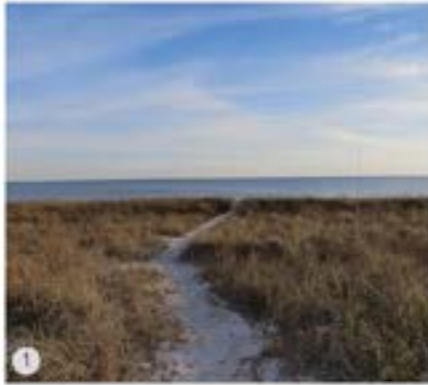
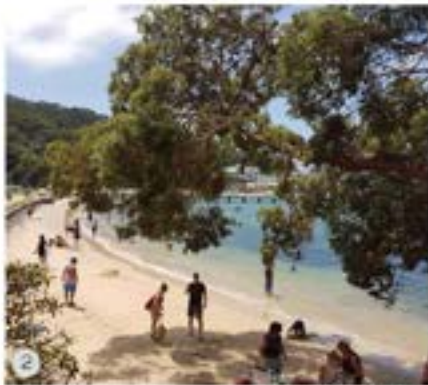
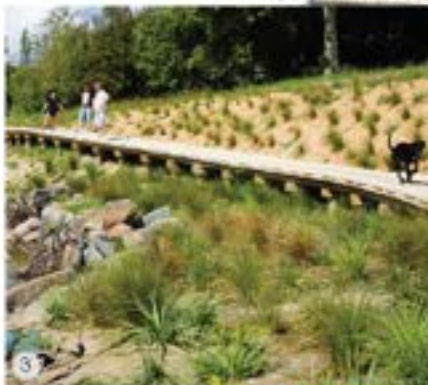
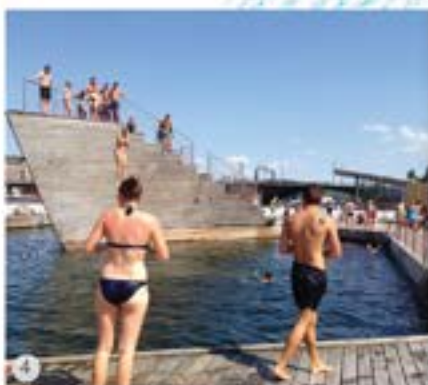
1. Infiltration zone
2. The beach
3. Riparian planting to bank
4. Timber deck + boardwalk
5. Concrete wall edge
6. Retained salt marsh
7. Lawn
8. Concrete path

- Location of the boardwalk above the king tide level (or other suitable level);
- Resolution of stormwater drainage and the impact that this could have on the beach;
- Requirement to ensure that localised flooding is eliminated;
- Ensuring that in large events stormwater can be safely conveyed through the swale and into the river without causing flooding;
- Maintenance required to ensure that the sand is well-maintained and free of debris, similar to the way that the ocean beaches are cleaned on a regular basis.

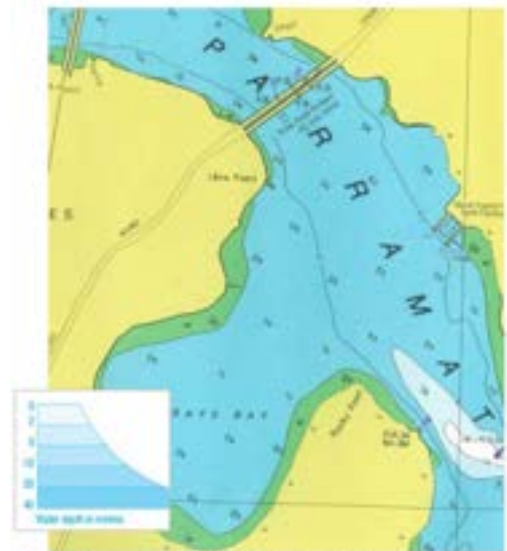
Figure 14: Extract of AUS Chart 203 (Australian Hydrographic Service showing approximate river water depths within the study area at Chart Datum which approximates to Lowest Astronomical Tide).

Figure: Approximate river depths at Brays Bay Reserve at Low Tide (AUS Chart 203)

The site has also been identified as having potential shallow depths. A review of the available information on water depths is shown in the figure below (from AUS Chart 203) which shows the depths in the river at lowest astronomical tide. This indicates that water depth varies in the river adjacent to the reserve between 1 and 2m. Water depths will need to be considered in the location, and form of the pool.

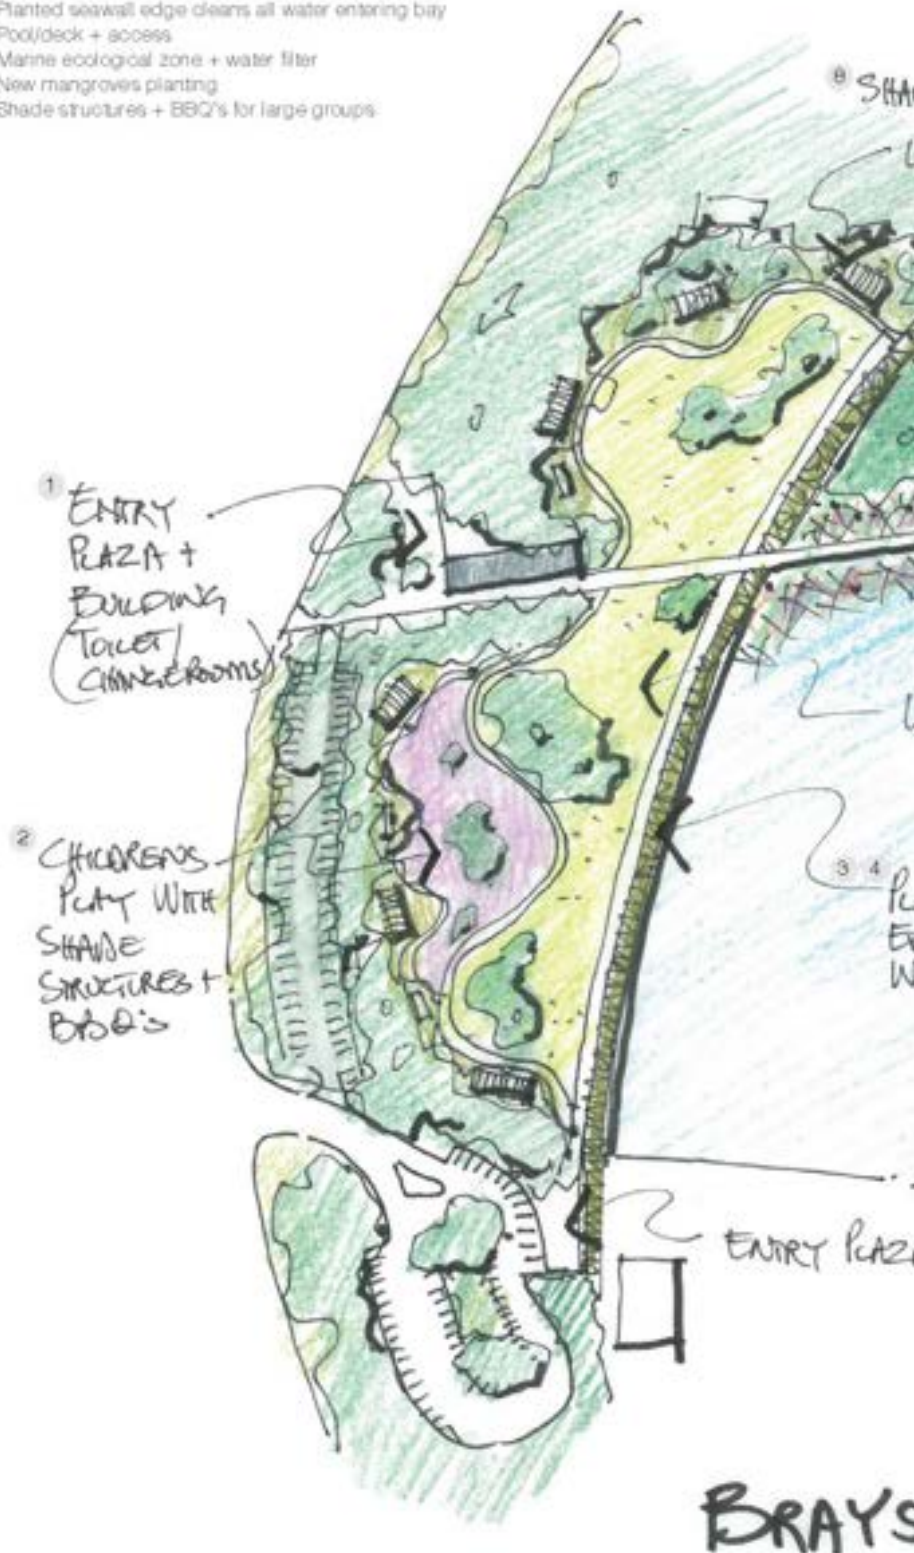
1. Entry plaza + building (toilet/changerooms)
2. Childrens play with shade structure + BBQ's
3. Entry plaza
4. Planted seawall edge cleans all water entering bay
5. Pool/deck + access
6. Marine ecological zone + water filter
7. New mangroves planting
8. Shade structures + BBQ's for large groups
